Technical Information Regarding the Continuous Galvanizing Method vs. Batch Galvanizing for Coating Guardrail

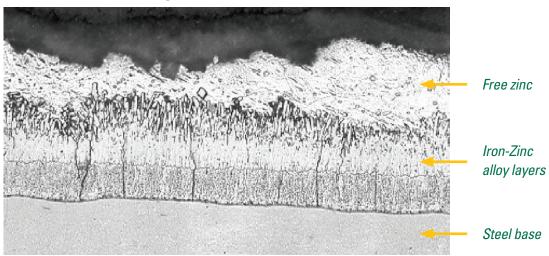
Micrograph Section of Batch Galvanized Coating

The difference between the coating structures is readily seen whereby the batch galvanized product has about half of its coating in the form of iron-zinc alloy layers which have grown from the steel base. In contrast, the continuously galvanized coating consists of virtually 100% free zinc with only a 'sub-microscopic' alloy bonding layer.

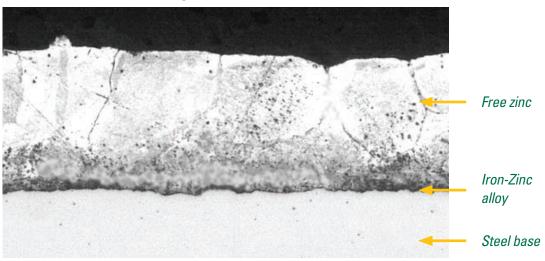
Micrograph Section of Continuous Galvanized Coating

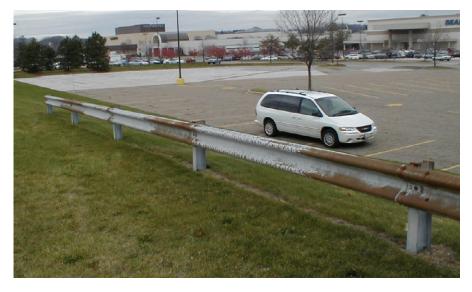
This effect is apparent when viewing guardrail which has been in service for sufficient time to allow exposure of its alloy layers to the environment. Since batch galvanized product consists of about 50% iron-zinc alloy layers, the <u>visual lifetime</u> prior to the appearance of rust is lowered by the presence of iron in the batch coated item. The following photograph depicts red rust from alloy layers corrosion even though microscopic examination proves that there are residual galvanized alloy layers intact on the surface. In addition, a systematic end-to-end variation in coating thickness is frequently observed as shown below.

When a coated steel article such as guardrail is withdrawn from a liquid zinc bath, there occurs gravity-induced draining of the liquid from the high end of the article and also from high spots on the formed profile. Thus, rust-like appearance and systematic end-to-end variation are noted on batch coated rail.

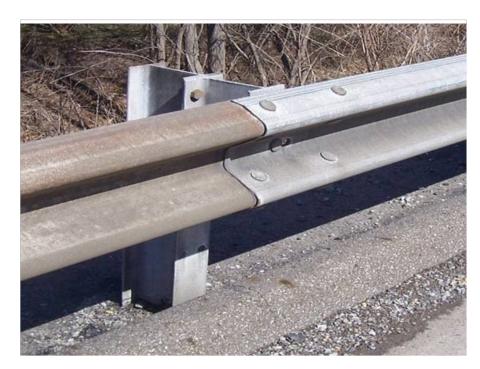
This photograph was taken in April, 2009, fifteen years after erection and service of Gregory rail (on the right) on the Pennsylvania Turnpike between Pittsburgh and Youngstown. This section does not show any corrosion problem at this transverse sheared edge or at bolt holes. The section on the left of the photograph is not of Gregory origin.

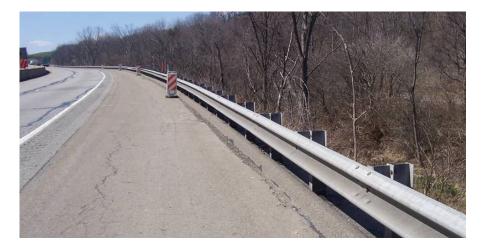
Theoretical indications regarding the effectiveness of sacrificial edge protection have been confirmed by actual observations under conditions of real exposure. In that regard, Gregory has a large body of experience in a wide area of the United States. A typical installation of guardrail on the Pennsylvania Turnpike (in an area where road de-icing salts are used in the winter and between the industrial cities of Pittsburgh and Youngstown) shows no significant corrosion of sheared edges after 15 years' exposure as the following photograph shows.

A longer view of the same installation (left) showing all the product in excellent condition after 15 years exposure

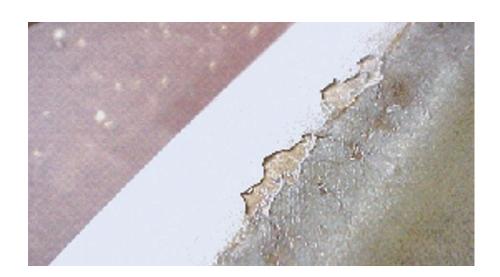
We had previously noted that a batch galvanized article has about half of its coating in the form of iron zinc alloy compounds. These are notoriously brittle and thus tend to crack when the article is deformed or impacted. In contrast, a continuous galvanized coating is virtually 100% ductile free zinc. It is not uncommon to see coating damage on batch galvanized areas where there has been accidental deformation or impact damage as below:

Example of coating fracture and spalling due to impact damage on batch galvanized guardrail

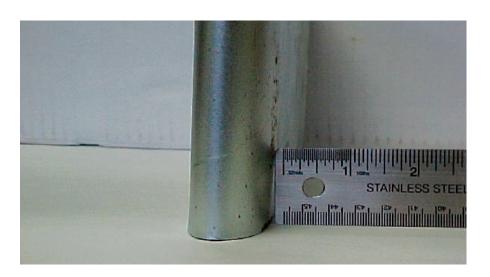
In contrast, a continuous alloy-free coating can readily be bent nearly 180 degrees without cracking or peeling as shown below.

The steel sample was a flat section coated to Type II guardrail standards and then formed in a 180° bend to show the coating ductility

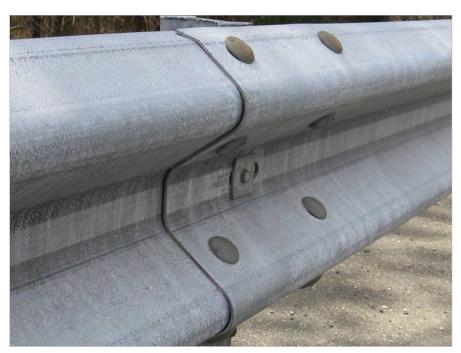
In contrast to the above, Type I guardrail exposed near Charlottes-ville, VA for the same time period shows little or none of the rough corrosion products on the surface and appears to have changed little during its nearly 15 years of exposure along an interstate highway (photo below).

This photograph of a
Gregory guardrail
product installed in
Charlottesville, VA in 1994
was taken in April of 2009.
The sheared transverse
edge and bolt hole edges
are corrosion protected
by galvanic action.

The obviously more mild corrosion conditions for Charlottesville are mainly attributed to lower snowfall, almost half as much as Pittsburgh and more rapid melting, both effects leading to lesser road salt exposure on the guardrail. The total precipitation in Charlottesville as (rain or melted snow) is slightly higher than it is in Pittsburgh (42.6 inches/yr. vs. 37). The previously referenced Phoenix area has an annual precipitation of fewer than 10 inches and virtually no snowfall. These comments and observations should facilitate decisions on choosing Type I or Type II for a given geographic area.
