U.S. Department
of Transportation
**Federal Highway
Administration**

- MFLEAT Terminal

Name of system: MFLEAT Terminal
Type of system: Terminal
Test Level: MASH Test Level 3 (TL3)
Testing conducted by: KARCO
Date of request: June 16, 2018
Date initially acknowledged: July 17, 2018

MFLEAT - MASH FLEAT - MGS System

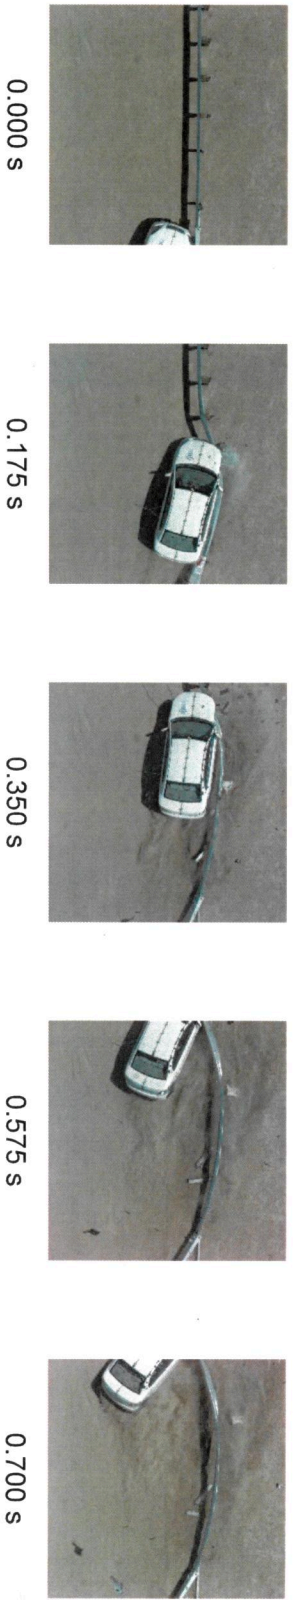
Figure 2 Summary of Test 3-34

MASH 2016 Test 3-34 Summary

General Information	
Test Agency	KARCO Engineering, LLC.
KARCO Test No	P37028-01
Test Designation	3-34
Test Date	3/27/17
Test Article	
Name / Model	MFLSAT -SP-MGS Terminal
Type	Guardrail Terminal
Installation Length	170.9 ft. (52.1 m)
Terminal Length	39.6 ft. (12.1 m)
Road Surface	Medium to fine silty sand
Test Vehicle	
Type / Designation	1100C
Year, Make, and Model	2011 Kia Rio
Curb Mass	2,495.6 lbs (1,132.0 kg)
Test Inertial Mass	2,415.1 lbs (1,095.5 kg)
Gross Static Mass	2,576.1 lbs (1,168.5 kg)

Impact Conditions	
Impact Velocity	61.93 mph (99.66 km/h)
Impact Angle (LON)	15.3°
Impact Angle (Terminal)	19.6°
Location / Orientation	26.9 in. (682 mm) downstream of post 1
Impact Severity	21.6 kip-ft (29.2 kJ)
Exit Conditions	
Exit Velocity	N/A
Exit Angle	N/A
Final Vehicle Position	41.2 ft (12.6 m) downstream
Vehicle Snagging	6.7 ft (2.0 m) traffic side
Vehicle Pooketing	Minor
Vehicle Stability	None
Maximum Roll Angle	Satisfactory
Maximum Pitch Angle	-7.4°
Maximum Yaw Angle	-5.5°
	46.8°

Occupant Risk	
Longitudinal OIV	15.7 ft/s (4.8 m/s)
Lateral OIV	12.5 ft/s (3.8 m/s)
Longitudinal RA	-8.7 g
Lateral RA	-6.0
THIV	18.4 ft/s (5.6 m/s)
PHD	10.2 g
ASI	0.69
Test Article Deflections	
Static	2.3 ft. (0.7 m)
Dynamic	2.7 ft. (0.8 m)
Working Width	3.1 ft. (1.0 m)
Vehicle Damage	
Vehicle Damage Scale	01-RFQ-2
CDC	01RFEW1
Maximum Intrusion	Negligible

3-34 (1100C)	<p>KARCO Test No. P37028-01. An 1100C (2,425 lb) passenger car impacting the terminal at a nominal impact speed and angle of 100 km/h (62.2 mph) and 15 degrees, respectively, with the corner of the vehicle bumper aligned with the critical impact point (CIP) of the length of need (LON) of the terminal. This test is primarily intended to evaluate occupant risk and vehicle trajectory criteria.</p> <p>The test vehicle, a 2011 Kia Rio 4-door sedan weighing 2,415.1 lb (1,095.5 kg), impacted the downstream end of the impact head 26.9 in. (682 mm) downstream of Post 1 at impact speed and angle of 61.93 mph (99.66 km/h) and 15.3 degrees, respectively. The impact angle relative to the terminal was 19.3°. The vehicle was contained and redirected by the guardrail before separating from the test article near Post 7 and coming to rest near Post 9, 41.2 ft (12.6 m) downstream of the point of initial impact. The vehicle remained upright and stable throughout the impact sequence and did not leave its lane. The test vehicle sustained moderate damage to the front right side with negligible occupant compartment deformation. The test article received extensive damage from Post 1 through Post 7. The Occupant Impact Velocities (OIV) and ridedown accelerations are within the recommended limits. In summary, the MASH FLEAT terminal passed all evaluation criteria for Test 3-34.</p> <p>There were no design modifications used on this test. The test was conducted on 3/27/17.</p>	PASS

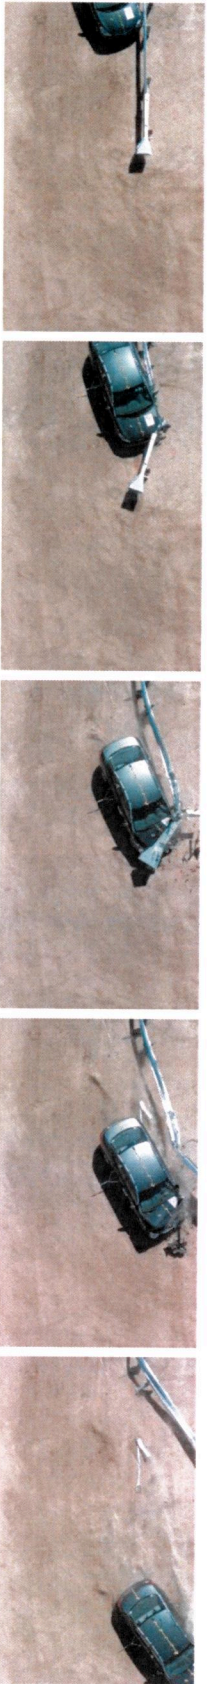
Figure 2 Summary of Test 3-37

MASH 2016 Test 3-37 Summary

General Information	
Test Agency	KARCO Engineering, LLC.
KARCO Test No.	P38080-01
Test Designation	3-37
Test Date	3/30/18
Test Article	
Name / Model	MFLEAT -SP-MGS Terminal
Type	Guardrail Terminal
Installation Length	83.3 ft. (25.4 m)
Terminal Length	39.6 ft. (12.1 m)
Road Surface	Medium to fine silty sand
Test Vehicle	
Type / Designation	1100C
Year, Make, and Model	2012 Hyundai Accent
Curb Mass	2,505.5 lbs (1,136.5 kg)
Test Inertial Mass	2,427.2 lbs (1,101.0 kg)
Gross Static Mass	2,601.4 lbs (1,180.0 kg)

Impact Conditions	
Impact Velocity	60.84 mph (97.92 km/h)
Impact Angle	25.5°
Location / Orientation	3.1 in. (79 mm) upstream from post 3
Impact Severity	55.7 kip-ft (75.5 kJ)
Exit Conditions	
Exit Velocity	32.4 mph (52.1 km/h)
Exit Angle	30.1°
Final Vehicle Position	97.5 ft (29.7 m) Downstream
Vehicle Snagging	23.5 ft (7.2 m) Field side
Vehicle Pocketing	Mirror
Vehicle Stability	None
Maximum Roll Angle	Satisfactory
Maximum Pitch Angle	-6.3°
Maximum Yaw Angle	5.8°
	25.0°

Occupant Risk	
Longitudinal OIV	31.8 ft/s (9.7 m/s)
Lateral OIV	8.2 ft/s (2.5 m/s)
Longitudinal RA	-9.6 g
Lateral RA	4.2 g
THIV	32.8 ft/s (10.0 m/s)
PHD	10.4 g
ASI	0.98
Test Article Deflections	
Static	9.0 ft. (2.7 m)
Dynamic	14.3 ft. (4.4 m)
Working Width	14.9 ft. (4.5 m)
Debris Field	18.1 ft. (5.5 m) Downstream
	61.1 ft. (18.6 m) Field Side
Vehicle Damage	
Vehicle Damage Scale	01-F/L3
CDC	01F/E/W2
Maximum Intrusion	0.3 in. (8 mm)
